NAVAL POSTGRADUATE SCHOOL MONTEREY CALIF
BALLISTIC DAMAGE OF GRAPHITE-EPOXY PLATES.(U)
JUN 77 G A EATON

BALLISTIC DAMAGE OF GRAPHITE-EPOXY PLATES

George Arthur Eaton

June 1977

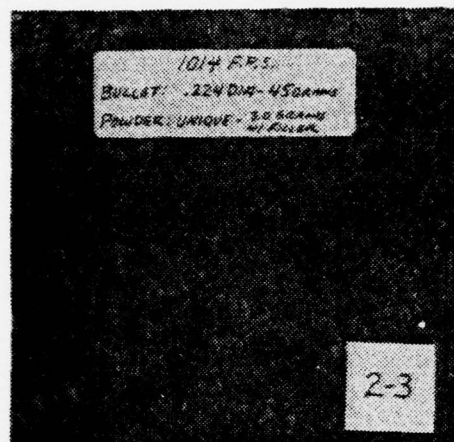
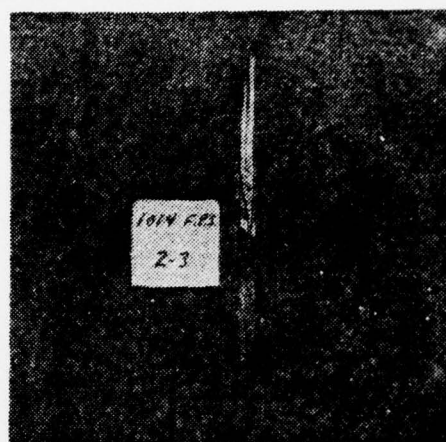
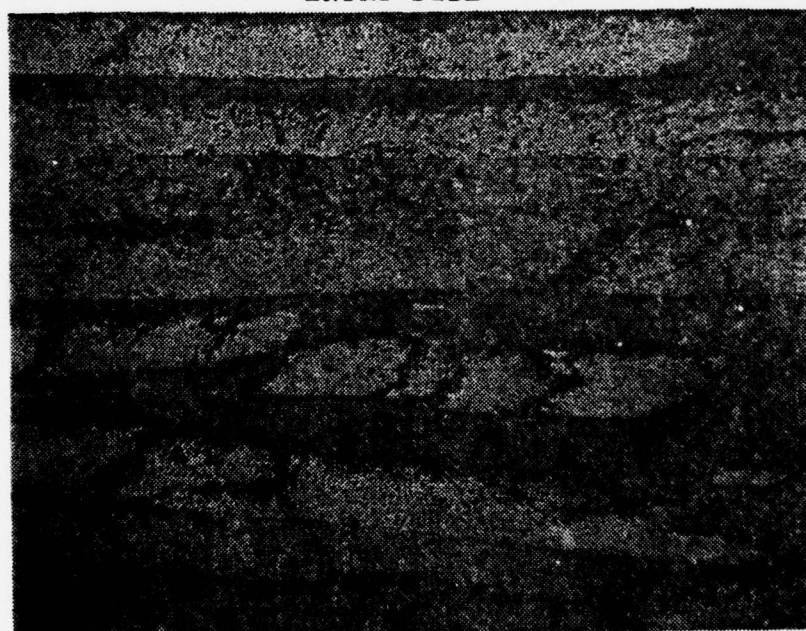
Figure 5 - MICROGRAPH OF SPECIMEN DAMAGED AT 1014 FPS

During the first test series the damaged specimens were cut transversely through the center of the hole, and a section along this line was removed for examination. These samples were mounted in cold-set plastic and polished for microscopic examination. Figure 4 shows a specimen ready for the microscope. The samples were examined and photographed at a magnification of 80X. Typical results are shown in Figures 5 through 11.

When a graphite-epoxy plate is subjected to ballistic damage, the resulting hole is round but not smooth, and the material at the edge of the hole is delaminated. Fibers in the outer lamina on the exit side, which were broken by the passage of the projectile, tend to delaminate and separate, and this damage extends for some distance from the hole in the fiber direction. Fibers which are not broken by the projectile, on the other hand, do not delaminate, except perhaps in the immediate vicinity of the hole. In addition, only fibers from the outermost lamina delaminate and separate; fibers from the 45° laminae, although broken, did not delaminate, except in the immediate vicinity of the hole. Thus the damaged area is roughly elliptical in shape, with the major axis in the direction of the fibers of the outer exit-side lamina. Figures 23 and 24 show the variation of damage area with projectile velocity. As can be seen, the damage area decreases as velocity is increased. In addition, at low velocity the separation of the fibers was very pronounced. As the velocity of the projectile increased up to the maximum tested velocity of 4000 feet per second, the separation of the fibers became less but was still visible.

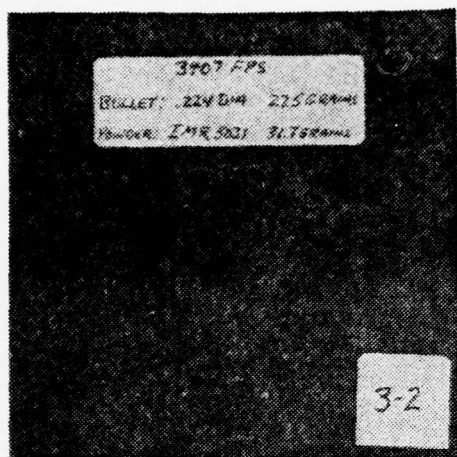
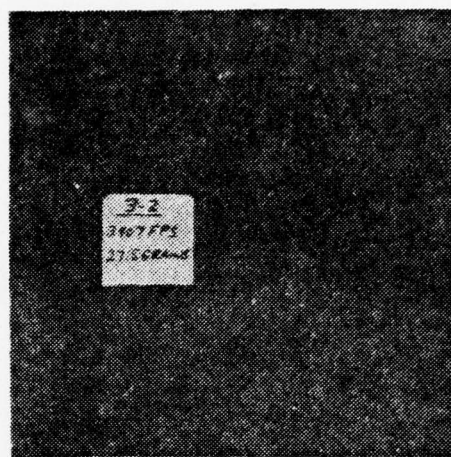
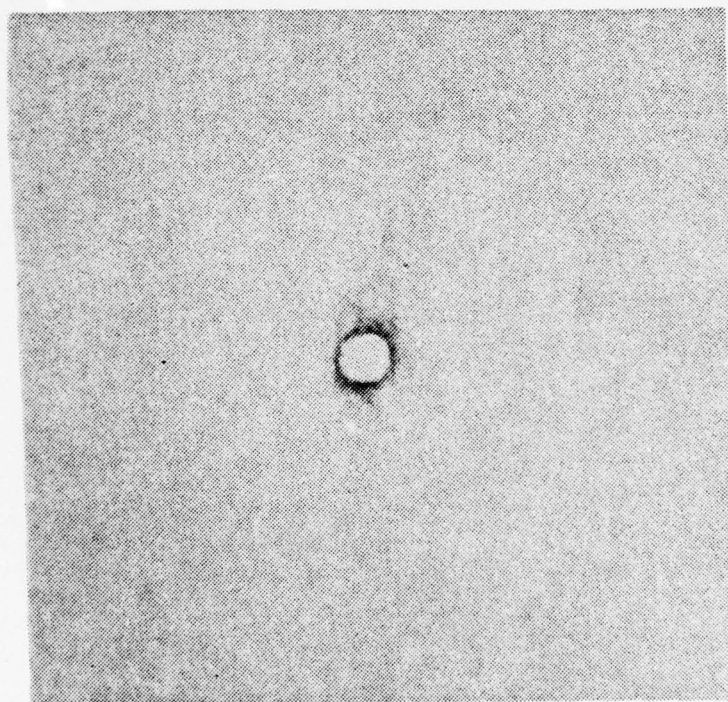
Figure 12 - COMPARISON OF X-RAY AND PHOTOGRAPH OF SPECIMEN
DAMAGED AT 3407 FPS

The effect of mass variation did not appear to be a major factor in damage area or extent of fiber separation due to ballistic impact. The damage done to the specimens was nearly uniform for the three masses investigated. Figures 12, 13, and 14 depict the variable-mass specimens and the damage experienced.

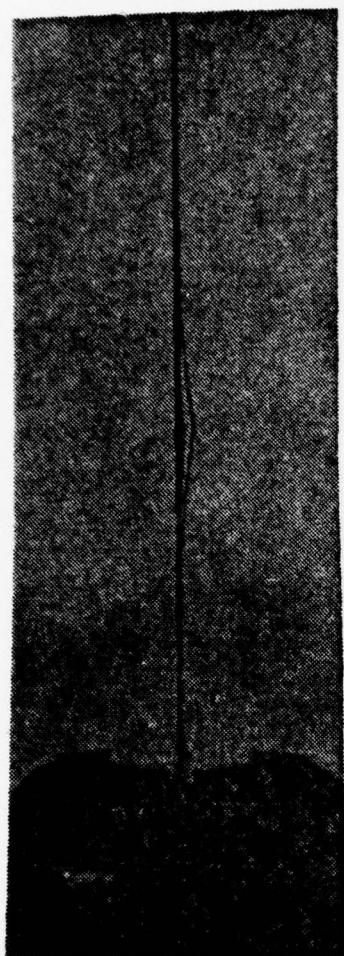
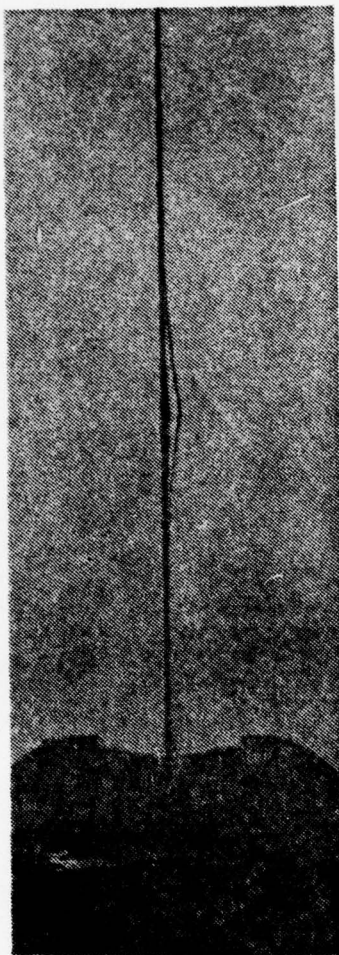
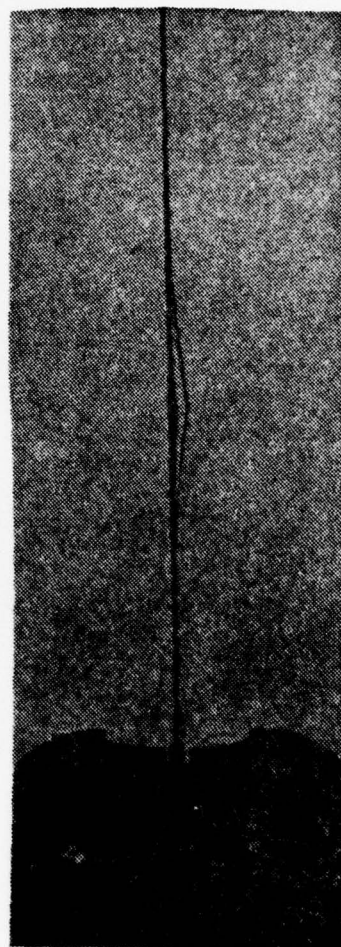
Figure 20 - TENSILE TEST LOADING-TO-FAILURE SEQUENCE

The maximum loading at failure was recorded. Figures 20, 21, and 22 illustrate the sequence of events leading to and including failure of a specimen. The outer laminae of the composite specimens (0° direction) were the only laminae that experienced this separation and protruding. The second ply (45° direction) appeared to remain intact until final failure. The three mechanically drilled control specimens also experienced this separating and protruding above and below the hole, even though they did not have any prior delamination caused by ballistic damage. As loading was applied to these specimens they reacted the same way as the ballistically damaged specimens behaved up to and including failure. The undamaged control specimens showed no sign of physical change while being loaded until they broke.

In the specimens tested that contained holes, which included damaged and drilled holes, the fracture line was at the hole or within the influence area of the hole. By passing a $+45^\circ$ line and a -45° line through the center of the hole and noting where these lines intersected the edge of the specimens, the influence area of the hole could be described. All the lines of failure passed within this 1.5 inch-by-1.5 inch area.

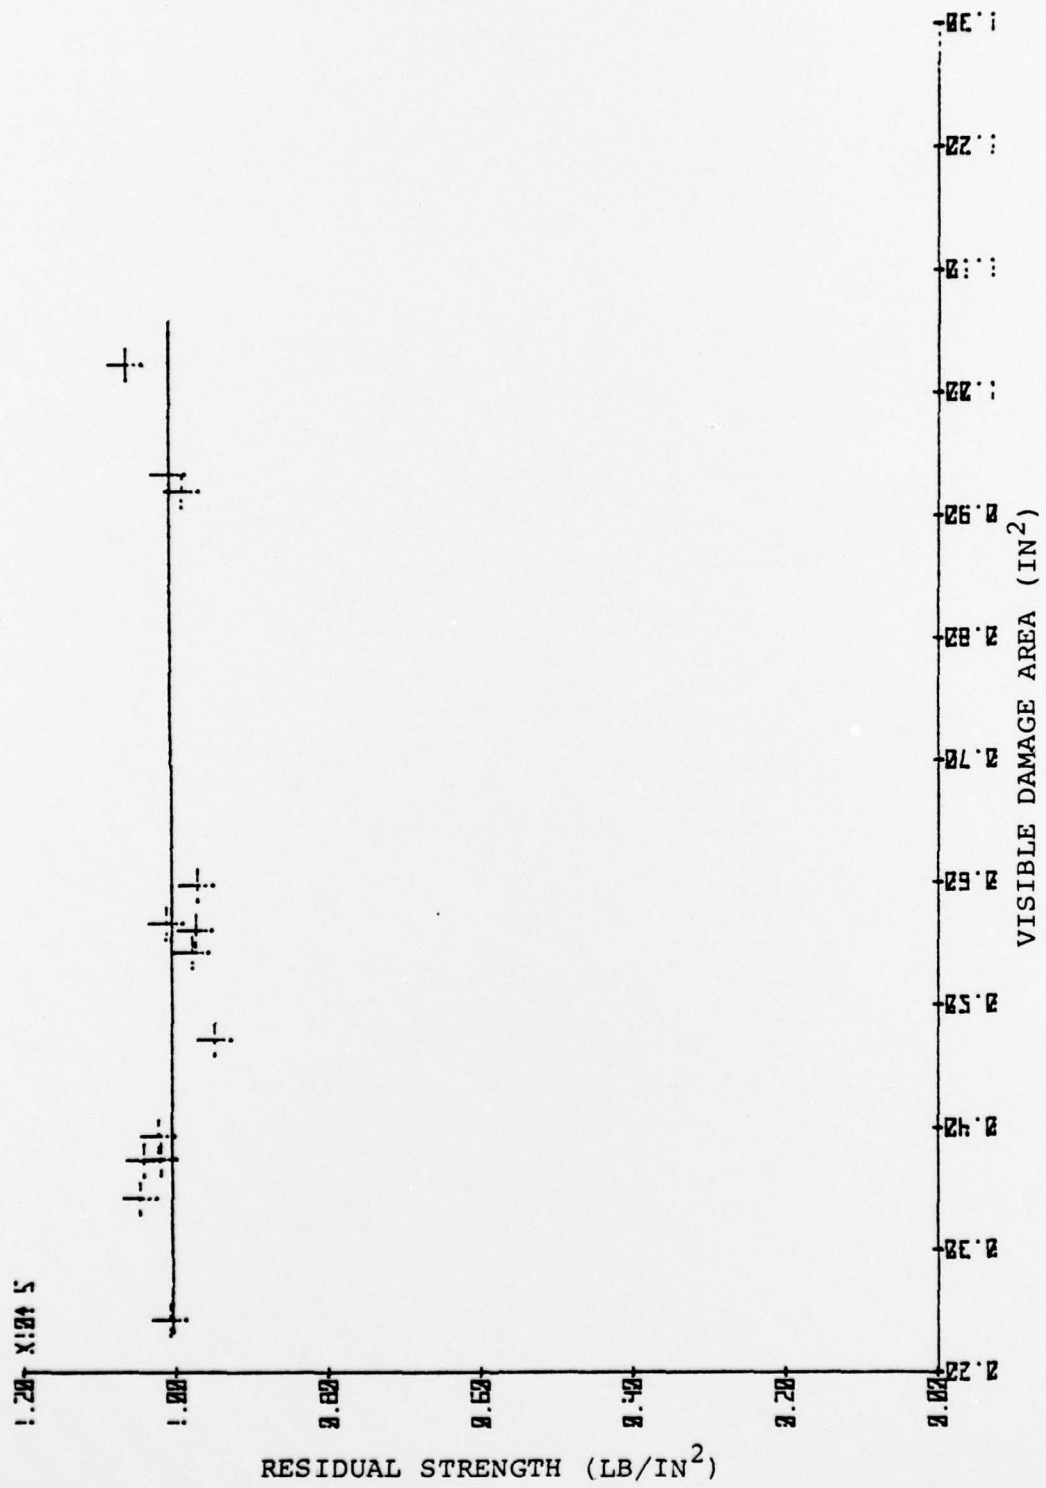
Figure 25 - VISIBLE DAMAGE AREA VS. RESIDUAL STRENGTH

Figure 25 shows the variation of the residual strength with visible damage area. This plot shows that the ultimate

average stress ("residual strength") across the material remaining after damage is nearly constant, i.e., is independent of the ballistic damage area. The residual strength level shown agrees within 1% with the residual strength exhibited by the drilled-hole control specimens. The loss in strength produced by the hole averages 5%; this result compares favorably with previous work [Refs. 5, 6] which indicated a loss of strength of about 10% for ballistic damage. It should be emphasized that "strength" or "residual strength" used in this context refers to the ultimate average stress rather than to the remaining load-carrying capability of the specimen. The latter quantity depends upon the amount of material remaining, i.e., upon the width of the specimen less the width of the damage area; the smaller the damage width, the greater the load-carrying capability remaining. However, regardless of the size of the damaged area, or of the damage width, the average stress at failure for the ballistically damaged specimens was essentially constant.
